# Army Lodging Wellness Recommendation

## Final Submittal - Fort Buchanan

May 17, 2004

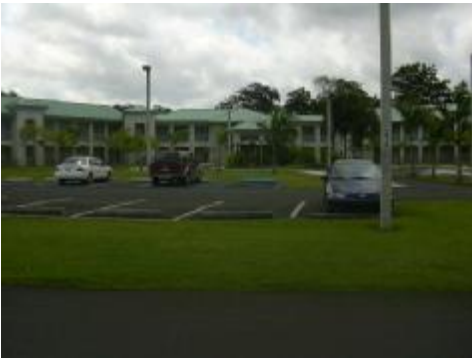
### ***Building 678***

Building 678, constructed in 1999, is a two story stucco and masonry building housing 20 standard rooms, 20 extended stay rooms and 4 family suites. This building is the main Lodging facility within the new Lodging campus area (buildings 678-681). This building is in good condition, although many of the rooms do not meet the Lodging size requirements. These room sizes are larger than standards but renovations to meet the sizing standards are not viable because of building configuration. The majority of the support spaces meet Army Lodging criteria, although some spaces are missing. Recommended renovations will eliminate 5 guest rooms to add support space requirements. The cost to make condition assessment improvements and modifications to meet functional criteria does not exceed 50% of the replacement cost.

Our recommendation is to retain Building 678 in the Fort Buchanan Lodging inventory. This facility will remain in the Fort Buchanan Wellness Solution and Lodging Master Plan.

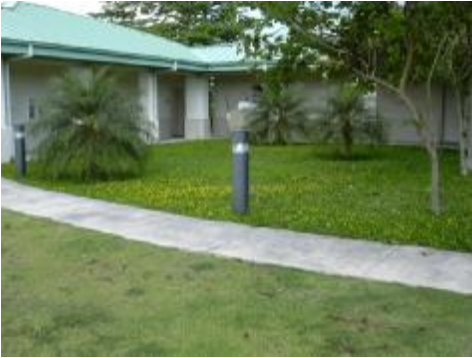
### ***Building 679***

Building 679, constructed in 1999, is a one story stucco and masonry building housing 4 standard rooms, 5 extended stay rooms, and 1 family suite. This building is one of the satellite buildings within the main Lodging campus area (buildings 678-681). This building is in good condition, although rooms do not meet the Lodging size requirements. Many of the room sizes are larger than standards, but renovations to meet the sizing standards are not viable because of building configuration. The majority of the support spaces meet Army Lodging criteria. The cost to make condition assessment improvements and minor modifications to meet functional criteria does not exceed 50% of the replacement cost.

Our recommendation is to retain Building 679 in the Fort Buchanan Lodging inventory. This facility will remain in the Fort Buchanan Wellness Solution and Lodging Master Plan.

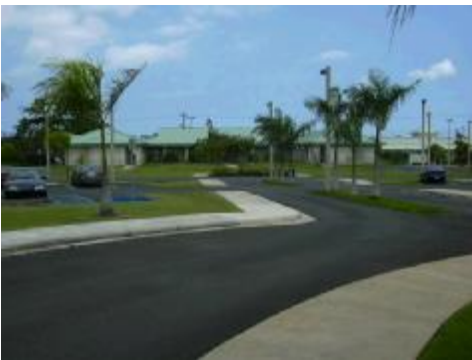
### ***Building 680***

Building 680, constructed in 1999, is a one story stucco and masonry building housing 5 standard rooms, 5 extended stay rooms, and 1 family suite. This building is one of the satellite buildings within the main Lodging campus area (buildings 678-681). This building is in good condition, although ,rooms do not meet the Lodging size requirements. Many of the room sizes are larger than standards, but renovations to meet the sizing standards are not viable because of building configuration. The majority of the support spaces meet Army Lodging criteria. The cost to make condition assessment improvements and minor modifications to meet functional criteria does not exceed 50% of the replacement cost.

Our recommendation is to retain Building 680 in the Fort Buchanan Lodging inventory. This facility will remain in the Fort Buchanan Wellness Solution and Lodging Master Plan.

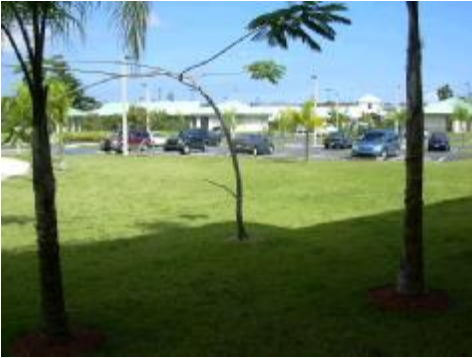
### ***Building 681***

Building 681, constructed in 1999, is a one story stucco and masonry building housing 4 standard rooms, 5 extended stay rooms, and 1 family suite. This building is one of the satellite buildings within the main Lodging campus area (buildings 678-681). This building is in good condition, although rooms do not meet the Lodging size requirements. Many of the room sizes are larger than standards, but renovations to meet the sizing standards are not viable because of building configuration. The majority of the support spaces meet Army Lodging criteria. The cost to make condition assessment improvements and minor modifications to meet functional criteria does not exceed 50% of the replacement cost.

Our recommendation is to retain Building 681 in the Fort Buchanan Lodging inventory. This facility will remain in the Fort Buchanan Wellness Solution and Lodging Master Plan.

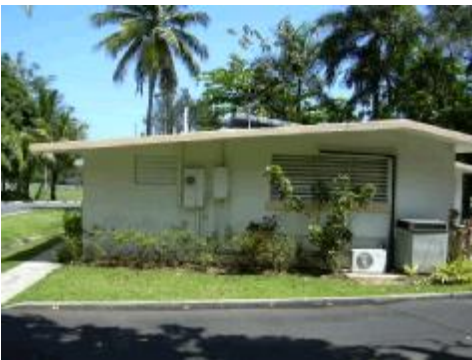
### ***Building 801***

Building 801, constructed in 1965, is a single story facility housing 2 extended stay rooms with a shared kitchen, dining, and living space. Originally constructed as a DVQ facility, this building is in poor condition, and does not meet the Lodging size requirements or provide appropriate support spaces. The cost to make condition assessment improvements to this facility will exceed 50% of the replacement cost.

Our recommendation is to remove building 801 from the Lodging inventory, allowing the installation to determine an alternate use for this facility. This facility will be removed from the Fort Buchanan Wellness Solution and Lodging Master Plan.

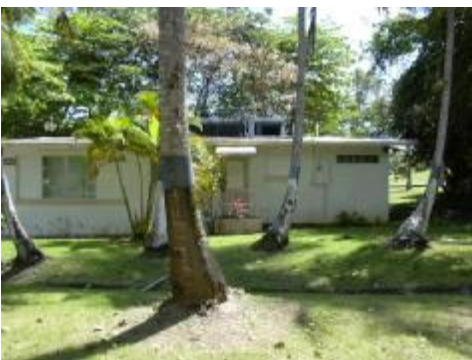
### ***Building 802***

Building 802, constructed in 1965, is a single story facility housing 2 extended stay rooms with a shared kitchen, dining, and living space. Originally constructed as a DVQ facility, this building is in poor condition, and does not meet the Lodging size requirements or provide appropriate support spaces. The cost to make condition assessment improvements to this facility will exceed 50% of the replacement cost.

Our recommendation is to remove building 802 from the Lodging inventory, allowing the installation to determine an alternate use for this facility. This facility will be removed from the Fort Buchanan Wellness Solution and Lodging Master Plan.

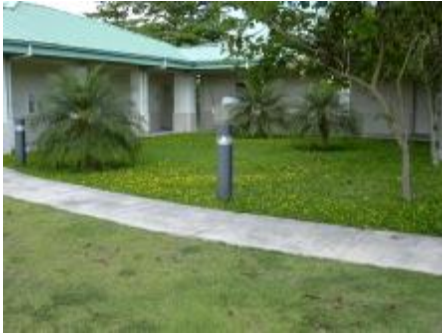
*Bldg 679  
Front View  
Ft. Buchanan, PR*

• Condition Assessment Cost	\$239,510
• Replacement Cost	\$1,213,639
• Condition Assessment to Replacement Cost Ratio	19.73%

Because the Condition Assessment to Replacement Cost Ratio is less than 50.00%, repair, and continued use of Building 679 is recommended.

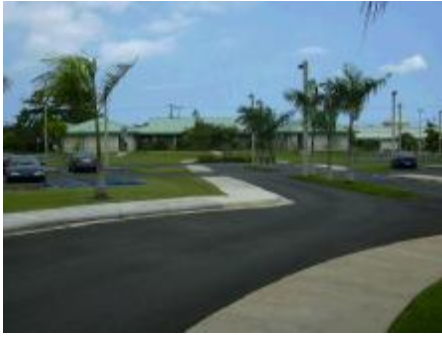
*Bldg 680  
Front View  
Ft. Buchanan, PR*

• Condition Assessment Cost	\$243,354
• Replacement Cost	\$1,471,319
• Condition Assessment to Replacement Cost Ratio	16.54%

Because the Condition Assessment to Replacement Cost Ratio is less than 50.00%, repair, and continued use of Building 680 is recommended.

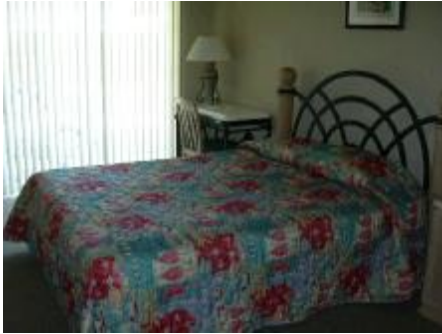
Bldg 681  
Typical Bedroom FF&E  
Ft. Buchanan, PR

- Analysis: The hard goods consist of headboards, night stands, dresser, chair, couch, coffee table, and TV stands. This furniture is five years old and is in good condition. The soft goods consist of drapes and blinds on the windows, TVs, mattresses and box springs, and bed coverings. These items are also five years old and are in good condition.
- Recommendation: No corrective action required.

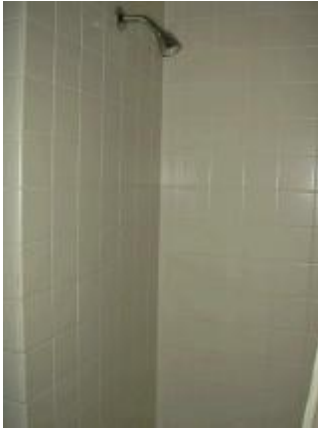
Bldg 681  
Typical Shower and Tile  
Ft. Buchanan, PR

- Analysis: The plumbing fixtures consist of floor mounted water closets, chrome plated brass faucets for the lavatory and bathtub, and chrome plated brass faucets for the stainless steel kitchen sink. All are in good condition.
- Recommendation: No corrective action required.

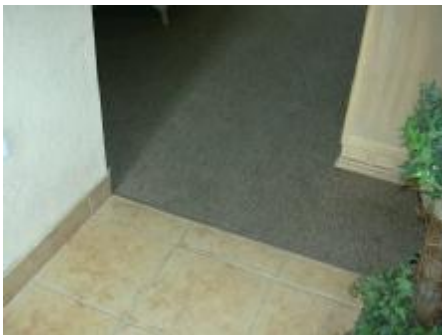
Bldg 681  
Typical Entrance Tile  
Ft. Buchanan, PR

- Analysis: The floor finishes consist of carpet in the guest rooms and offices; ceramic tile in the bathrooms and common areas; stone flooring in the guest room kitchenette and lavatory area, lobby, reception and building entrance areas; vinyl tile in the common areas; and concrete in the back-of-house areas. The carpet, ceramic tile and vinyl flooring is in poor condition.
- Recommendation: Replace the carpet and vinyl tile.
